Fatigue Failure of Development Space Shuttle Main Engine Turbine Blades

George C. Marshall Space Flight Center Science and Engineering Directorate Dr. Gregory R. Swanson ED22/Strength Analysis Group

HPFTP/AT

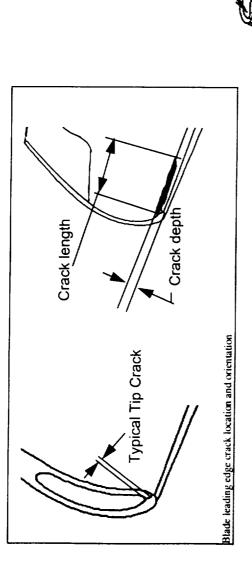
Blade Crack Development Locations

Blade tip crack originating at inside fillet radius

certification and flight by leading edge (resolved for - Tip initiation at core increasing core radius)

certification and flight by temperature, and by gold - Attachment at galling plating blade to reduce location (resolved for reducing attachment friction)

Blade attachment load face galling cracks identified at edge of galling

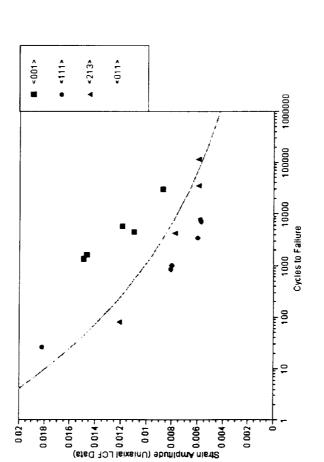
Fig. 4.3 Strain range Vs. Cycles to Failure for LCF test data (PWA1484 at 1200F)

Power Law Curve Fit ($R^{\wedge}2 = 0.468$): $\Delta \epsilon = 0.0238 \text{ N}^{-0.124}$

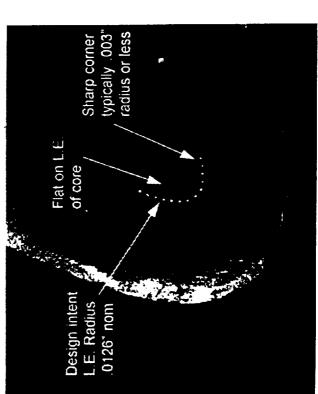
Development Blade Core Profile

- Sharp reentrant corner
- Wall thickness variation
- Resolved for certification and flight by increasing core radius and tighter control of core placement

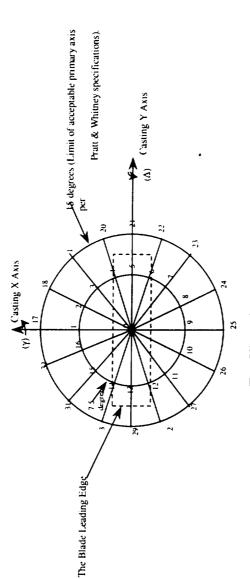
Top View of the Blade

* (33) orientations (cases) of (γ & Δ) with (9) (θ)orientations about each of these. * 16 cases with (γ & Δ) combined to 7.5 degrees, 16 with (γ & Δ) combined to 15 degrees, 1 case with

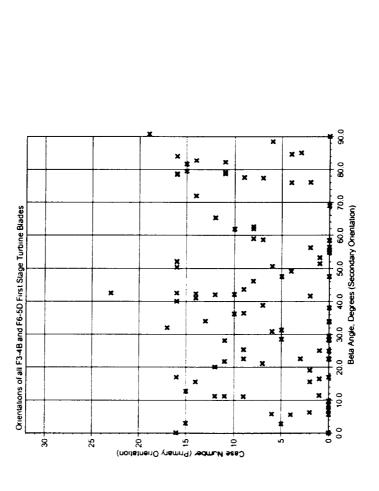
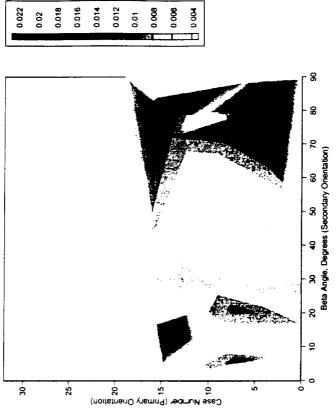
F3-4B and F6-5D First blades XXX FPI data, Contour Plot of Crack Length Across Blade Wall in Inches (0.02 is through wall for this plot)

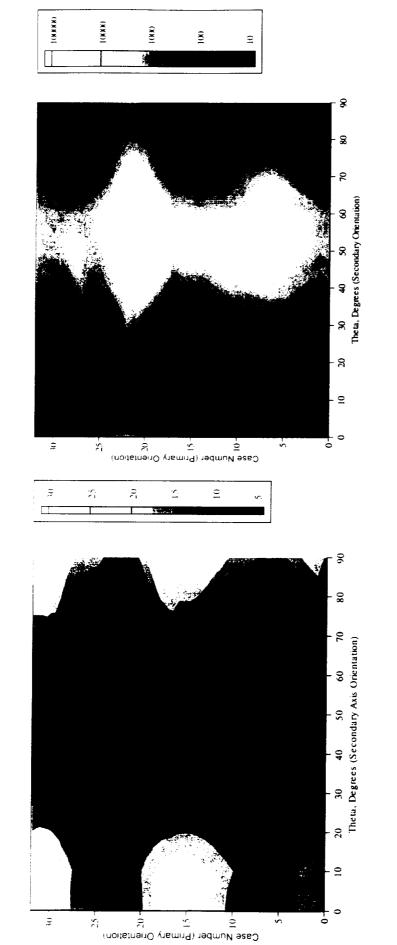
Maximum Resolved Shear Stress at Blade Tip

Dimensionless life at the first blade airfoil crack initiation point.
